TECHNICAL REPORT REMR-CO-3

CASE HISTORIES OF CORPS BREAKWATER
AND JETTY STRUCTURES

Report 7

NEW ENGLAND DIVISION

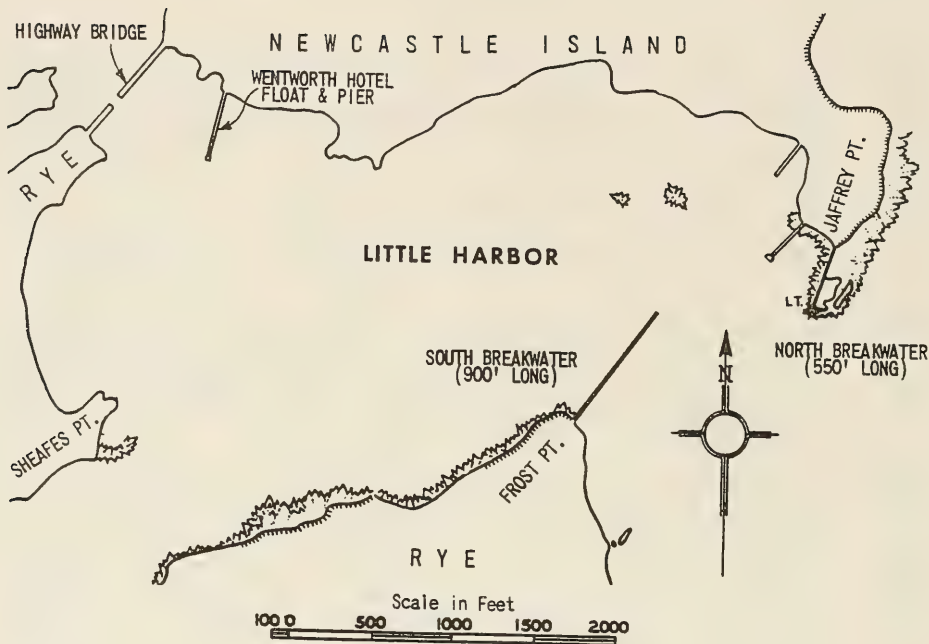
Figure 16. Plan view and cross sections of breakwaters at Little Harbor, N.H.

<u>Date(s)</u>	<u>Construction and Rehabilitation History</u>
1894- 1903	Two rubble-mound breakwaters were constructed to lengths of 550 and 900 ft on the north and south sides of the entrance to Little Harbor (Figure 16).
1905	Minor repairs were made using 476 tons of stone.
1959- 1974	Based on several visual inspections, the jetties were considered to be in poor condition.
1975	Seaward sections of the north and south jetties, 350 and 850 ft long, respectively, were repaired using 4 to 7-ton stone. The design cross section (Figure 16, inset) had a +12 ft mlw crown elevation, a 12- or 14-ft top width, and 1V:1.5H side slopes. The side slope on the seaward facing quadrant of the breakwater heads was 1V:2H. The cost for placing 7,800 tons of stone was \$159,500.
1983	An inspection showed that the north jetty had a few small areas of displaced stone, and the south jetty had substantial damage which was subsequently repaired along the seawardmost 150 ft.

1985	Visual inspection indicated the breakwaters were in good condition.

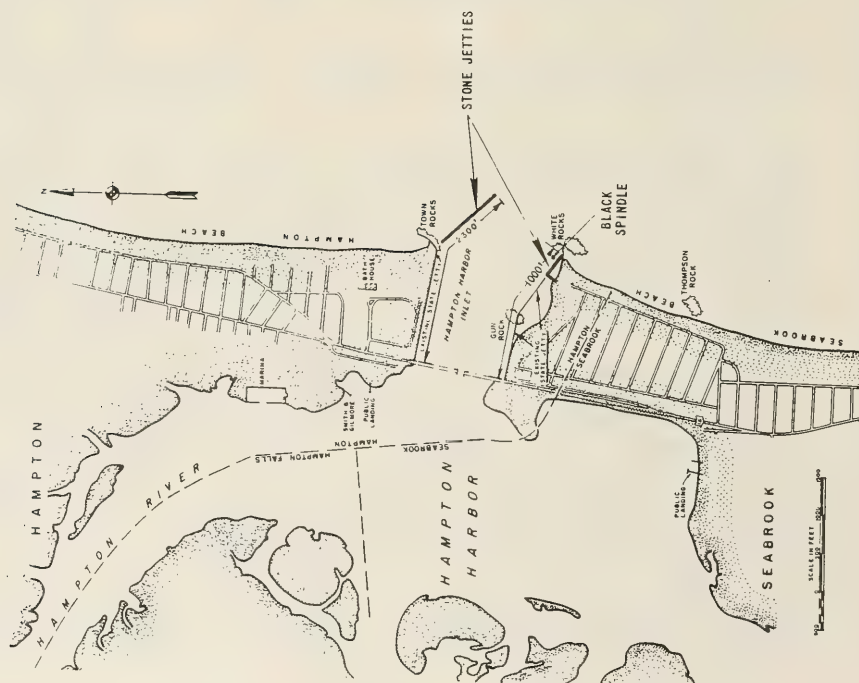
Figure 19. October 1984 photograph of jetties at Hampton Harbor, N.H.

1984	The jetties were inspected and found to be in excellent condition. Figure 19 is an aerial photograph of the jetties taken on 16 October 1984.

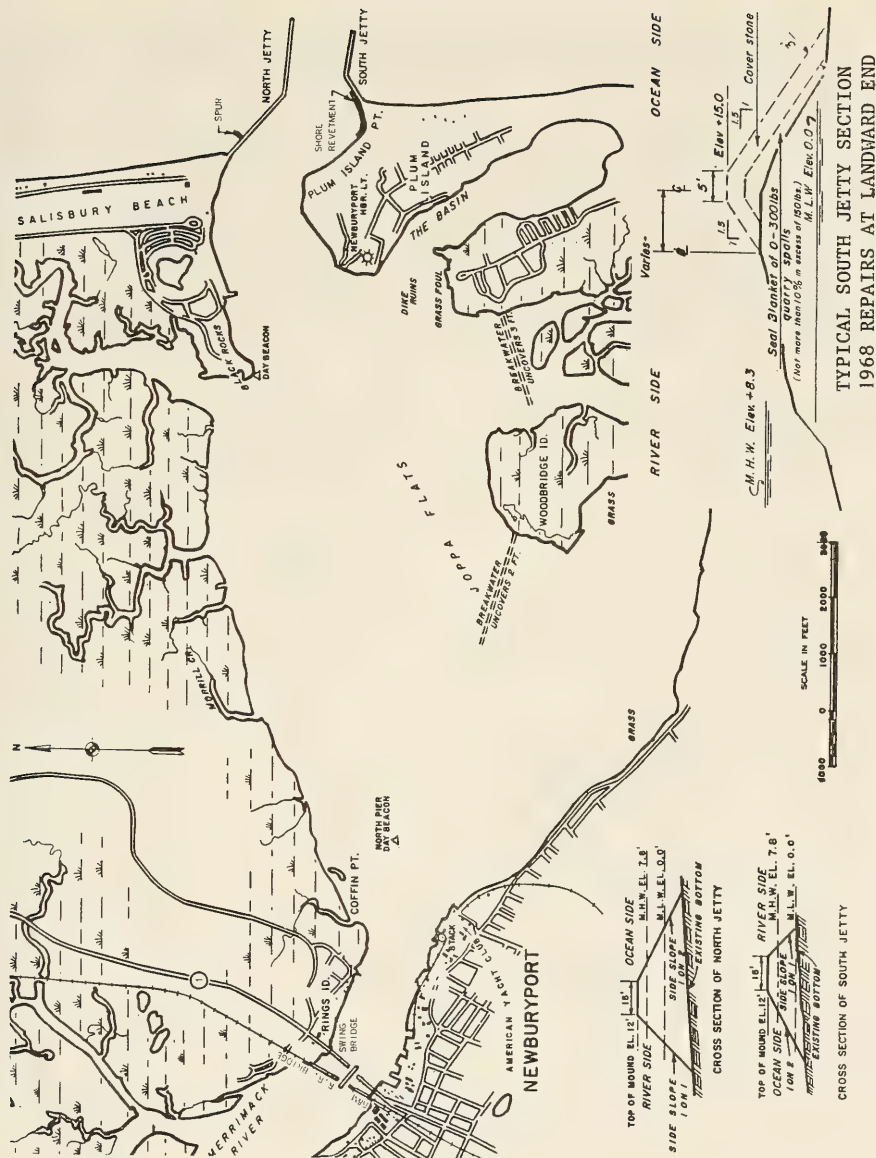
Figure 20. Location map and typical sections of jetties at Newburyport Harbor, Mass.

1963	An inspection showed both jetties were in poor condition.
1968-1970	Extensive repairs were made to 2,920- and 1,095-ft-long sections of the north and south jetties. The repaired sections would best define the existing lengths of the jetties (Figure 20, plan view). Also completed were 700 lin ft of revetment adjacent to, and landward of, the south jetty repairs. The north jetty repairs started from its reconstructed landward end at 1+00 and continued to the existing seaward end at 30+20. The south jetty repairs started from its reconstructed landward end at 0+00, stopped at 6+00, started again at 10+05 and continued to its reconstructed seaward end at 15+00. An undetermined length of south jetty seaward of 15+00 was not repaired. Seaward of 5+50 both jetties were built up to +12 ft mlw with a 15-ft crown width and slopes of 1V:1H and 1V:2H on channel and sea sides, respectively. The landward sections (Figure 20, inset) had 1V:1.5H side slopes, a crown width of 5 ft, and maximum crown elevations of +17 and +15 ft mlw on the north and south jetties, respectively. The stone size varied from a minimum of 0.5 tons at the landward ends to a maximum of 12 tons at the seaward ends. The estimated quantity of

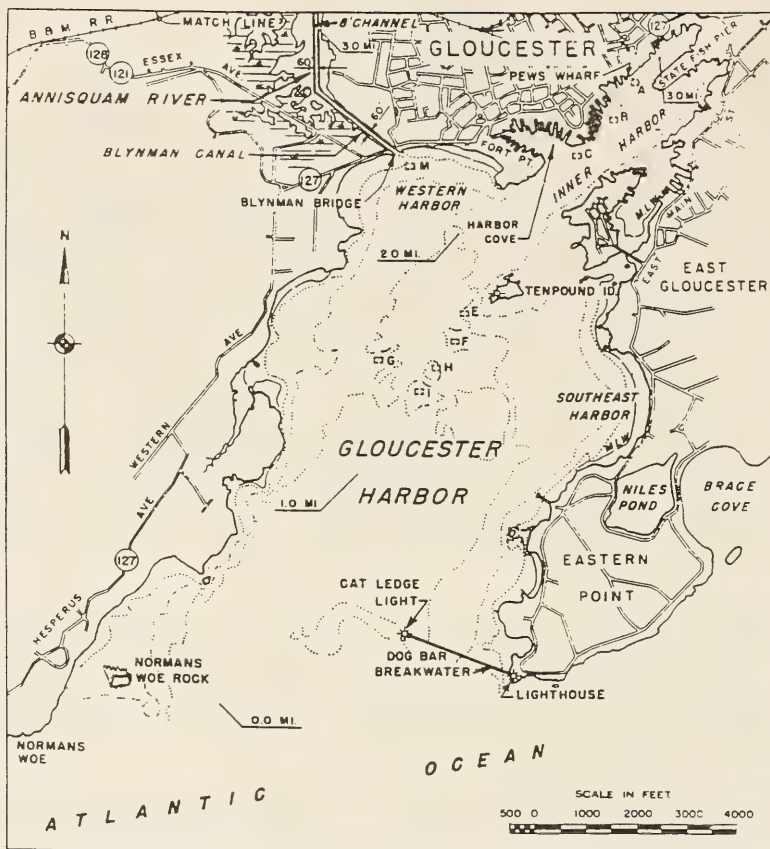
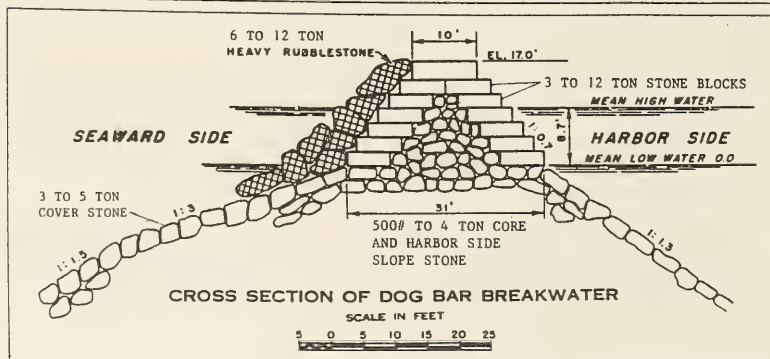
Figure 23. Plan view and typical section of Dog Bar breakwater at Gloucester Harbor, Mass.

1967-1978	Breakwater inspections, taken over this period, showed a gradual deterioration of the sea-side armor stone at several locations. Most of the damage was on the outer half of the breakwater.

1931-1940	Minor repairs were made to the superstructure in 1931, 1933-34, 1935, 1939, and 1940. The work (approximate totals in parentheses) included resetting (2,000 tons) and replacing (1,000 tons) stone blocks, placing rubble stone (7,000 tons) on the seaward face (Figure 23, inset), and placing iron pins (700) on the harbor side stone blocks to act as buttressing for the upper courses of stone. The total repair costs were \$35,700.
1962	A breakwater inspection showed the stone block superstructure was in good condition with only localized areas needing repair. The sea-side armor stone, placed during 1931-40, was in poor condition with several large cavities and a general subsidence along the entire breakwater length.
1965-1966	Repairs were made to the breakwater superstructure, and 10,920 tons of 6- to 12-ton armor stone were placed on the sea side between 0+00 (landward end) and 21+85. Displaced stone blocks were reset from 1+14 to 1+72 and 9+96 to 10+22. Total cost of the repairs was \$96,400.

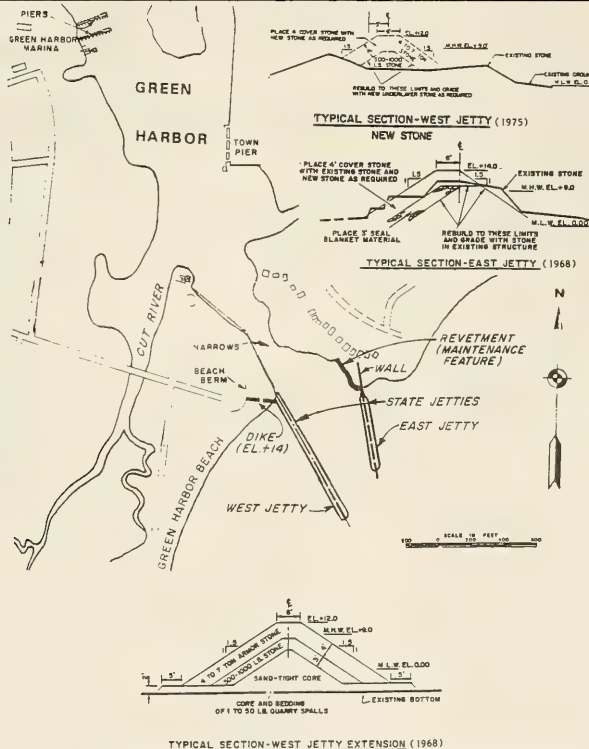
Figure 25. Plan view and cross sections of jetties at Green Harbor, Mass.

Date(s)	Construction and Rehabilitation History
1972-1974 (cont.)	worst areas as low as +4 ft mlw. It was estimated that 1,000 and 500 tons of new and salvageable stone, respectively, were needed to repair the jetty.
1975	The seaward 525-ft section of the west jetty was repaired to the 1968-69 design cross section using 4- to 7-ton cover stone and 500- to 1,000-lb underlayer stone as needed (Figure 25, inset). The repairs were made for a total cost of \$40,000.
1977	An inspection indicated that the east jetty was in good condition but that the west jetty needed some armor stone reset.
1986	Yearly inspections indicate that the jetties are in good condition. For the purpose of this report, the lengths of the east and west jetties are considered to be 645 and 850 ft long, respectively (the 1968-69 improvements plus approximately 150 ft of concrete wall landward of the east jetty repair section).

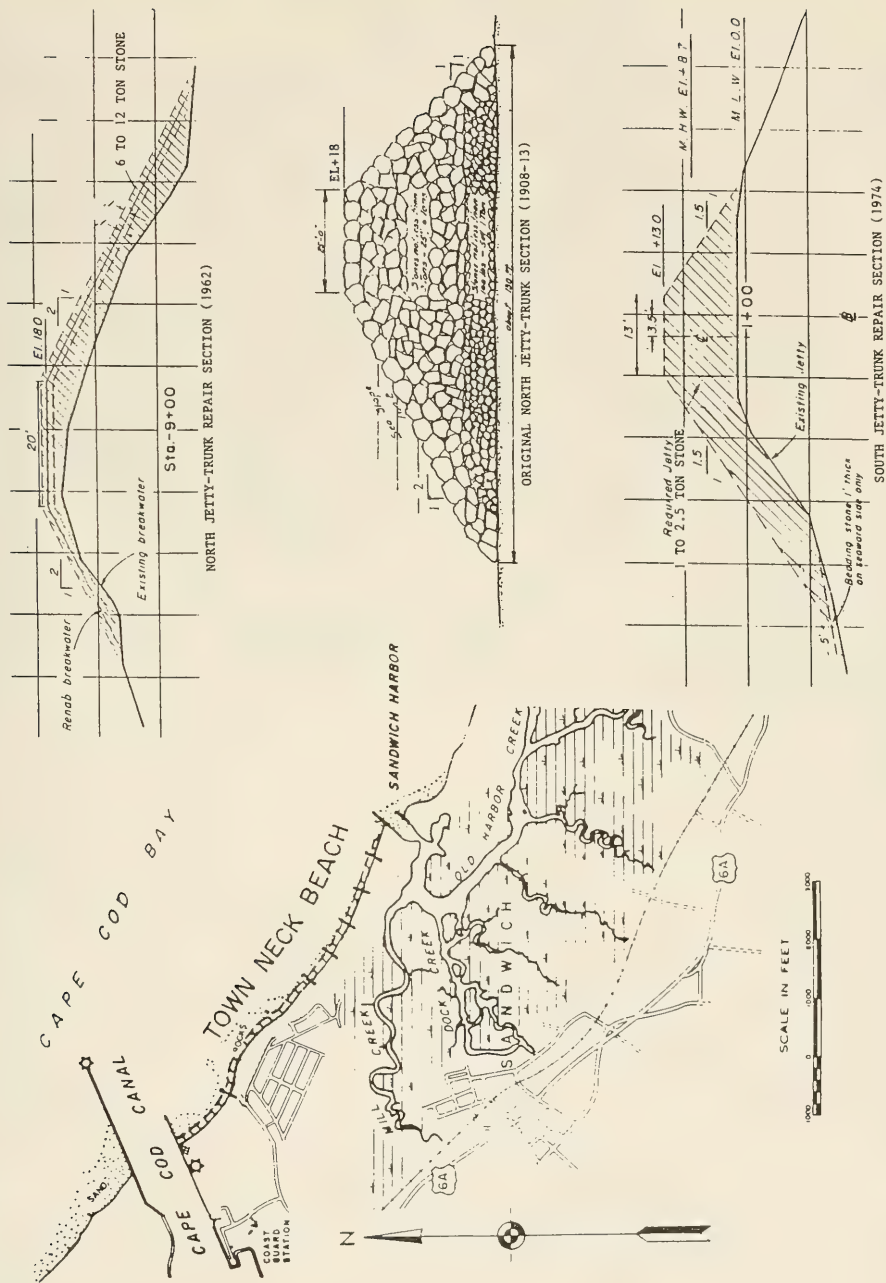
Figure 27. Plan view and typical sections of jetties at Cape Cod Canal, Mass.

1977	The jetties were visually inspected. The south jetty was found to be in good condition, while the north jetty needed repairs throughout its entire length.
1986	Recent yearly visual inspections indicated the jetties were in good condition.

1962-	The seaward 925 ft of the north jetty was rebuilt to +18 ft mlw. Stone 1963 placed on the structure weighed a minimum of 6 tons, except on the 125-ft-long head section, where the minimum size was 12 tons. The head section had a 25-ft crown width and a transition in side slopes from 1V:2H to 1V:3H in the seaward direction. A 20-ft crown width and 1V:2H side slopes were specified on the jetty trunk section. Prior to the repairs, typical crown elevations were from +14 to +18 ft mlw on the trunk section and from +7 to +18 ft mlw on the head section. The contract price for placing an estimated 20,000 tons of stone was \$260,000.
1967- 1974	Inspection reports indicate the north jetty was in good condition, while the south jetty was in poor condition with numerous voids and displaced slope stone along its entire length.
1974	The south jetty was rebuilt to +13 ft mlw. The rebuilt section was 690 ft long and terminated at the jetty's seaward end. Side slopes were 1V:1.5H. A 13-ft crown width and 5- to 7-ton stone were specified on the seaward 200 ft. The remaining section required a 10-ft crown width and 1- to 2.5-ton stone. A 1-ft-thick layer of bedding stone, 0 to 50 lb in size, was placed along the outermost 450 ft of the jetty's seaside toe. Prior to the repairs, crown elevations were typically from +3 to +8 ft mlw. The contract price for placing an estimated 15,500 tons of stone was \$224,800.

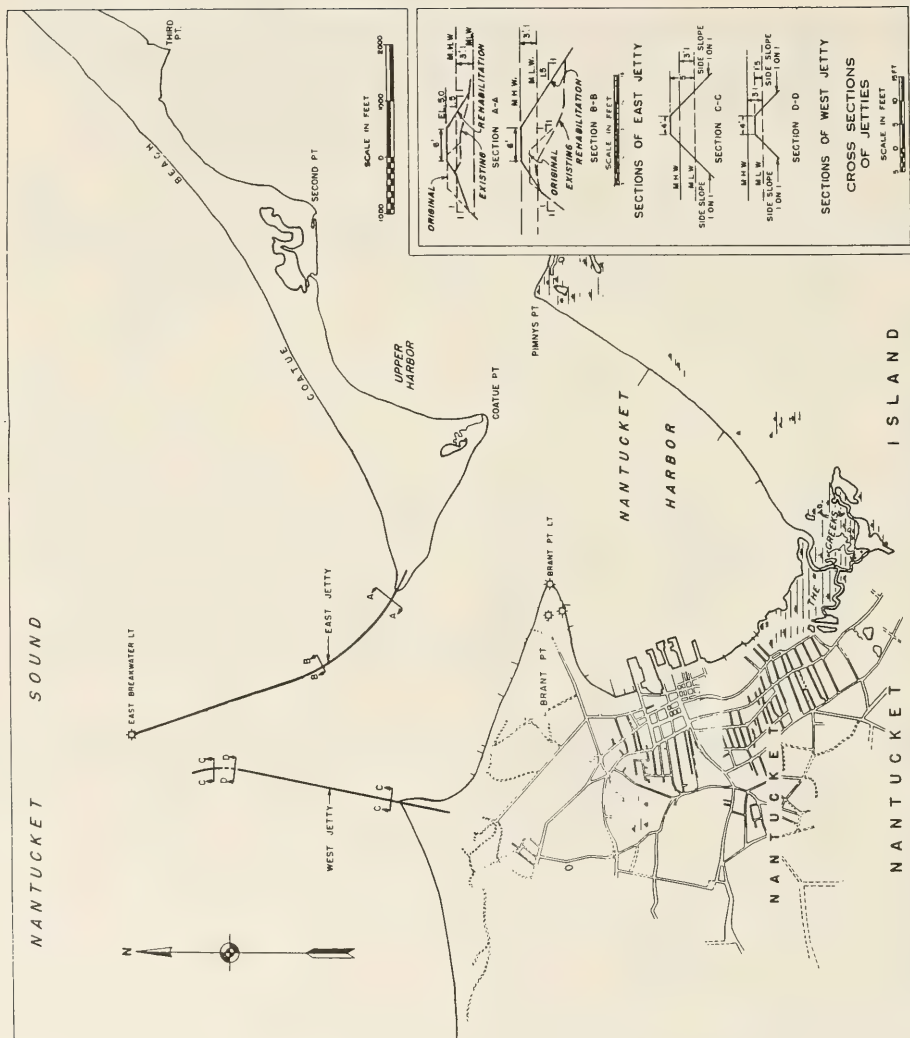
Figure 30. Plan view and typical sections of Nantucket Harbor Jetties, Nantucket Island, Mass.

1962- 1963	About 4,400 lin ft of the east jetty was rehabilitated. The repair sections were located from 5+50 to 6+00 and from 8+34 to 52+00. The jetty's seaward end was at approximately 52+75. The design crown width and side slopes were 6 ft and 1V:1.5H, respectively. The landward and seaward sections were raised to +5 and +3 ft mlw, respectively. Minimum stone size was 1.5 tons, with 75 percent of the total stone quantity in pieces weighing a minimum of 2 tons. Prior to repairs, the seaward section had typical crown elevations between +1 and -2 ft mlw. The repairs required 15,100 tons of stone for a total cost of \$181,000.
1967- 1977	Visual inspections indicated the east jetty was in fair condition with some displacement of stone noted. The west jetty was in poor condition, with most of the structure below mhw (+3 ft mlw).
1981	Yearly visual inspections indicated the jetties were in good condition.

1986	Present conditions of the jetties are not known.

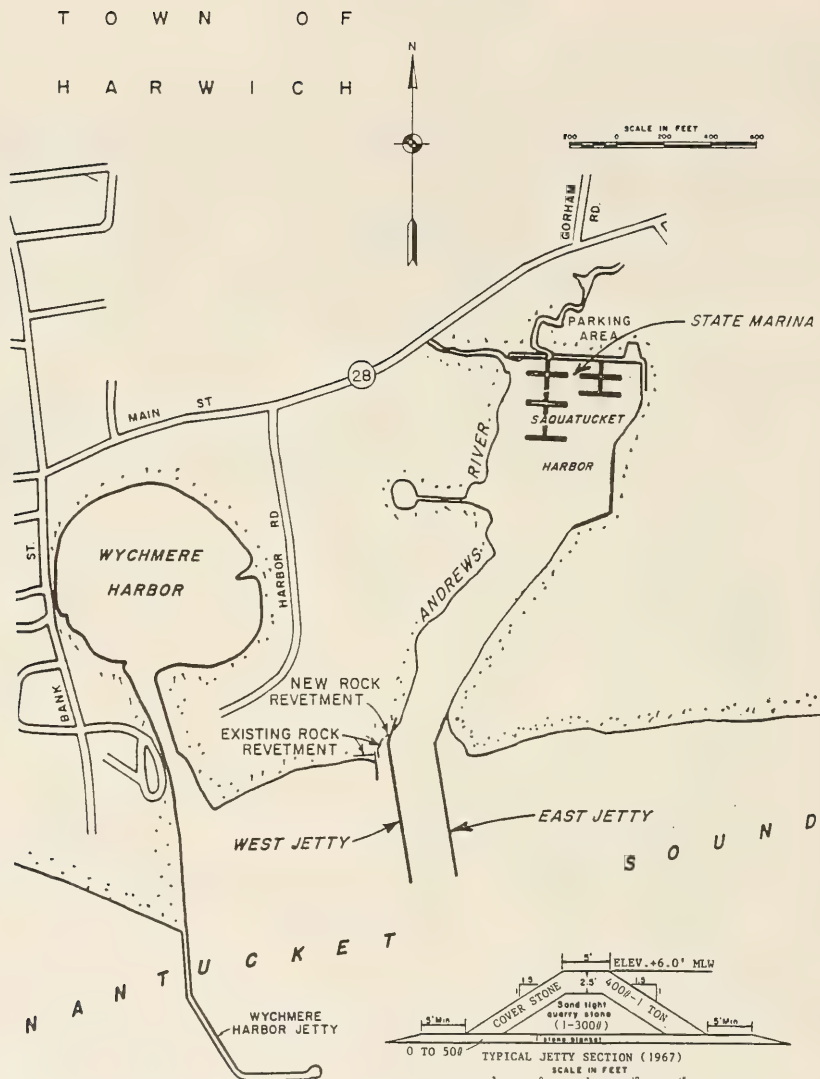
Figure 31. Plan view of Andrews River jetties, Harwich, Mass.

1974	Visual inspection indicated the jetties were in excellent condition.
1981- 1986	Yearly visual inspections indicated the jetties were in good condition.

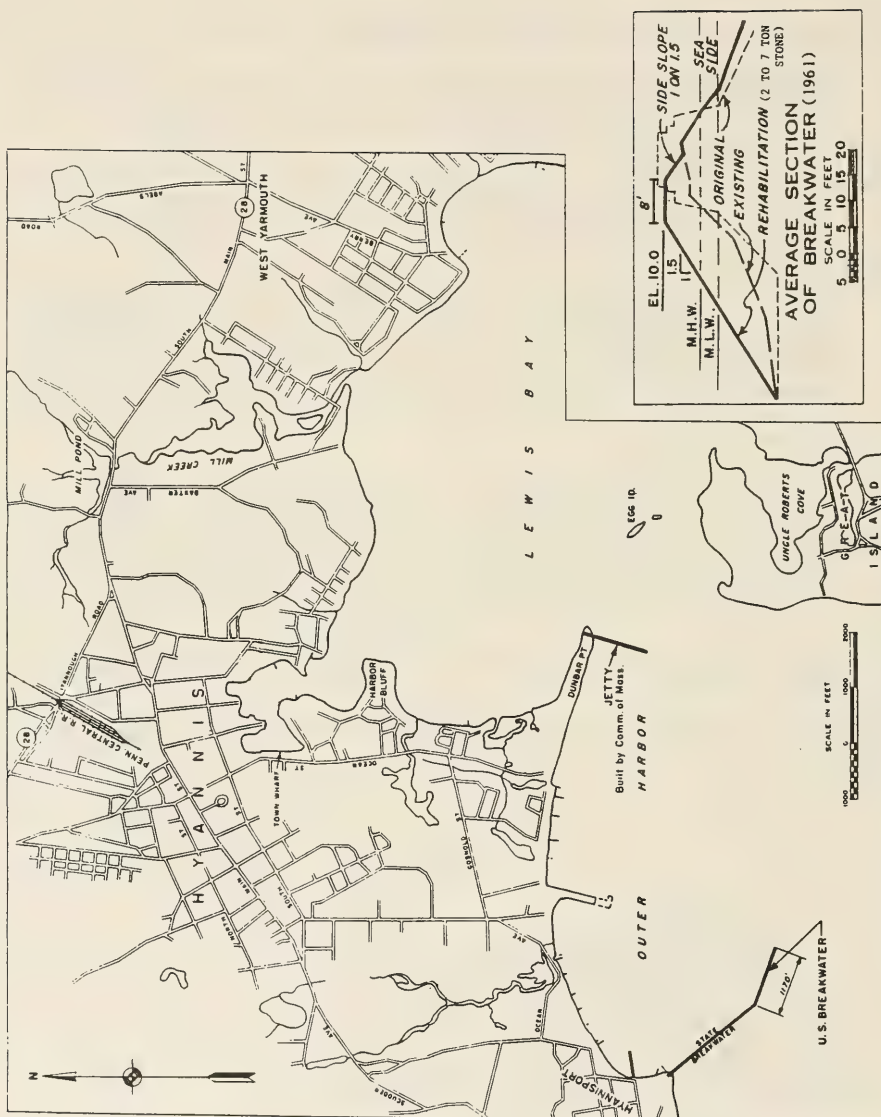
Figure 32. Location map of breakwater at Hyannis Harbor, Mass.

Date(s)	Construction and Rehabilitation History
1827- 1936	The breakwater (Figure 32, plan view) was constructed between 1827 and 1837 and rebuilt between 1870 and 1882. The inner leg of the breakwater, about 2,250 ft long, was built by the State of Massachusetts. The 1,170-ft-long outer leg of the breakwater was built and maintained by the Federal government. The rebuilt cross-section had a 10-ft crown width at +10 ft mlw and may have been of cut stone construction since the side slopes were nearly vertical. Minor repairs were made in 1936.
1950	The outer 1,170-ft-long leg of the breakwater and adjacent 10 ft of state breakwater were repaired with 1- to 6-ton stone. The repair geometry consisted of a 10-ft crown width at +10 ft mlw and 1V:1H side slopes. A total of 3,224 tons of stone was placed for a cost of \$29,200. Prior to the repairs, existing crown elevations varied from +5 to +10 ft mlw. The State portion of the breakwater was considered to be in poor condition.

1961	The outer leg of the breakwater was repaired from 0+00 to 7+80 and 10+75 to 11+15 (breakwater bend at 0+00, seaward end at 11+70). The repair section consisted of an 8-ft crown width at +10 ft mlw, 1V:1.5 side slopes, and 2- to 7-ton armor stone. Before the repairs, crown elevations were from +5 to +10 ft mlw. The repair costs were \$129,800 using a total of 13,588 tons of stone.
1966- 1974	Inspections indicated the Federal portion of the breakwater was in fair condition.
1982- 1986	Yearly visual inspections indicated the breakwater was in good condition.

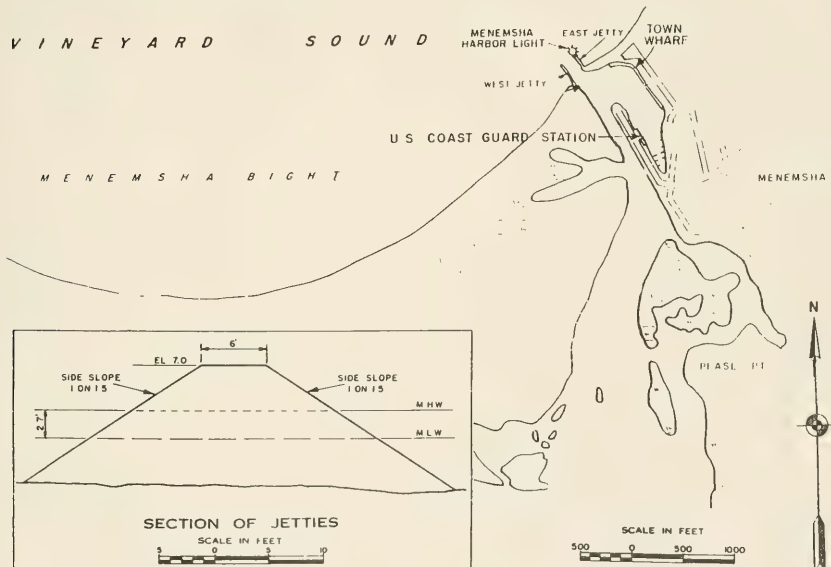
Figure 34. Plan view and typical section of Menemsha Creek jetties, Martha's Vineyard, Mass.

Date(s)	Construction and Rehabilitation History
1945	The east and west jetties, approximately 250 and 435 ft long, respectively, were constructed by non-Federal interests prior to 1945 (Figure 34). The project, adopted by the government in 1945, included maintenance of the riprap jetties.
1969	The west jetty was rebuilt by placing approximately 2,100 tons of cover stone and 900 tons of seal stone. The repairs were made over a distance of 435 ft at a contract cost of \$67,500. The design section consisted of a +7 ft mlw crown elevation, a 6-ft crown width, and 1V:1.5H side slopes.
1981	The east jetty was rebuilt with 20-to 400-lb core stone and 1- to 3-ton cover stone. The design section had 1V:1.5H side slopes and a 6-ft crown width at +7 ft mlw. The contract price for placing an estimated 2,750 tons of stone was \$91,600.
1982-1987	Annual visual inspections of the jetties indicated they were in good condition.

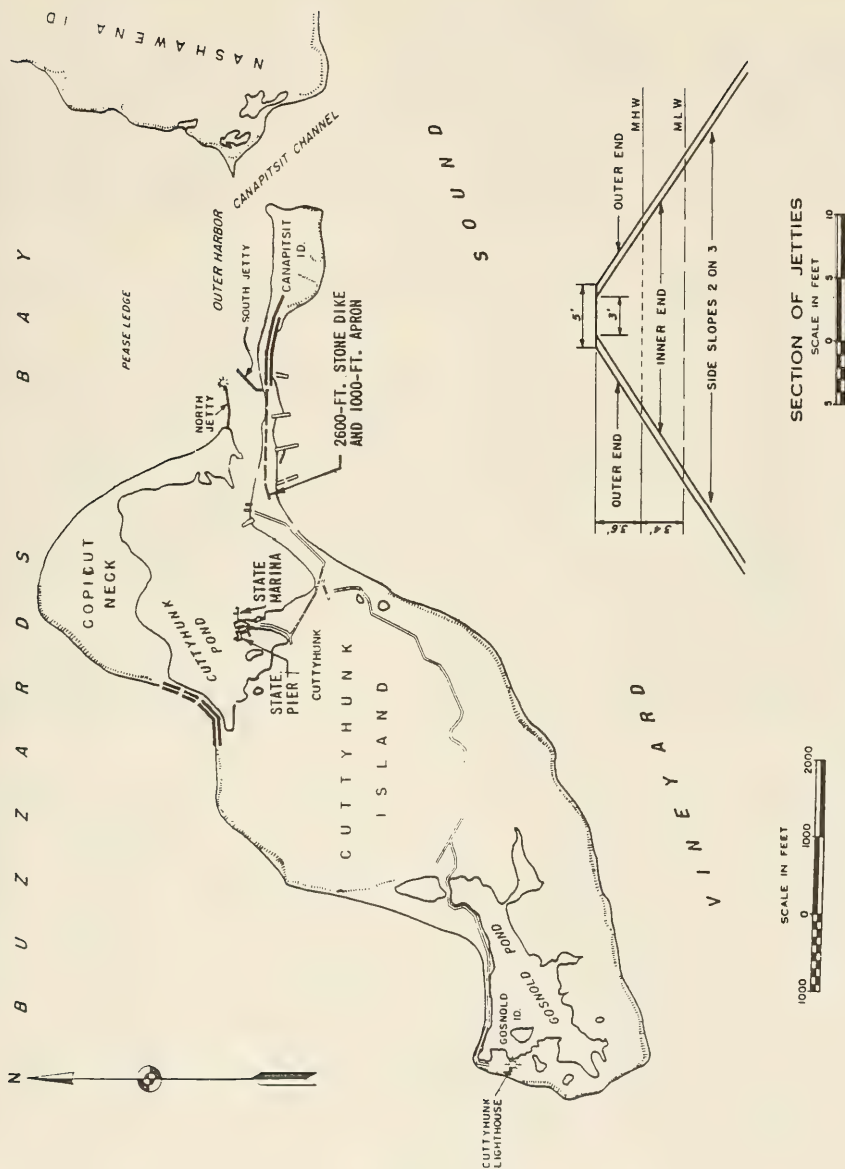
Figure 35. Jetties at Cuttyhunk Harbor, Mass.

<u>Date(s)</u>	<u>Construction and Rehabilitation History</u>
1906- 1935	During this period the north and south rubble-mound jetties, approximately 520 and 280 ft long, respectively, were constructed and maintained by the State of Massachusetts (Figure 35).
1937- 1939	In 1937 the Federal government adopted the Cuttyhunk Harbor Project, which included maintenance of the jetties. In 1939, repairs were made to the north jetty using 500 tons of stone at a cost of \$3,600. The repairs restored the crown elevation to +8 ft mlw.
1951	The north jetty was repaired using approximately 1,800 tons of stone at a cost of \$14,400. The stone ranged in size from 0.5 to 8 tons and was placed to an elevation of +7 ft mlw, 1V:1.5H side slopes, and a 3- to 5-ft crown width.
1962- 1977	Visual inspections indicated the north jetty was in good condition, and the south jetty was in very poor condition. During the early 1960's recommendations were made which included repair of the south jetty, and subsequent repairs were made.

1984- 1986	Annual visual inspections indicated the jetties were in good condition.

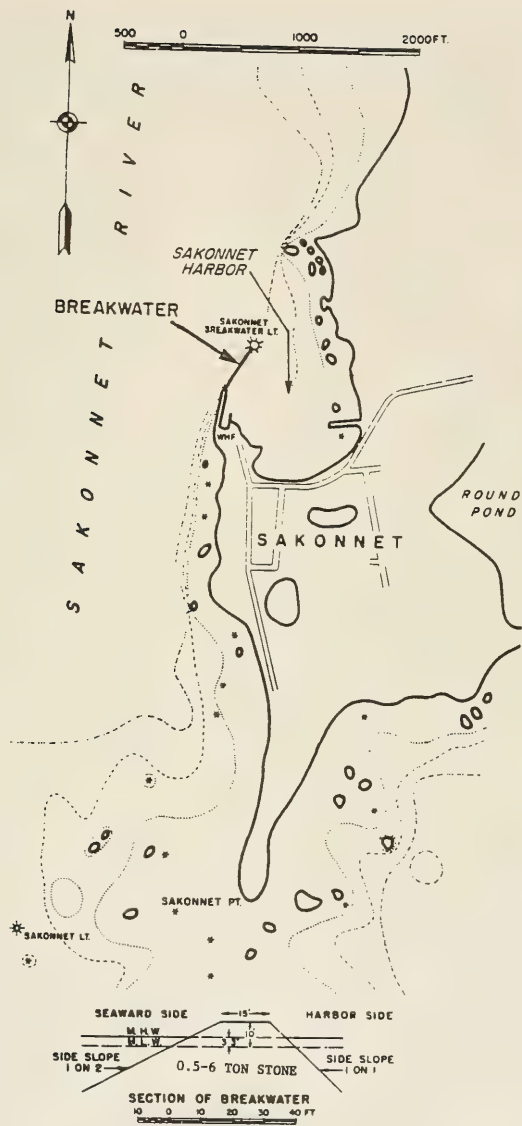
Figure 36. Plan view and typical section of breakwater at Sakonnet Harbor, R.I.

1960	A June topographic survey shows cross sections for the entire breakwater approximately 2 ft above the design cross section used in 1957. The reason for the apparent change in datum could not be found (for present report purposes).
1961	Repairs were made on three sections totaling 86 lin ft, including a 25-ft section at the seaward end and 9- and 52-ft sections located approximately 140 and 430 ft from the seaward end, respectively. The repairs were made with 0.25- to 5-ton stone placed to an elevation of +10 ft mlw, a 15-ft crown width, and slopes of 1V:2H and 1V:1H on the sea and harbor sides, respectively. Except for the outermost 15 ft of repairs, which appears to have subsided prior to June 1960, the repair areas were apparently damaged by storm waves sometime between the June 1960 survey and a visual inspection in February. The damaged areas had typically subsided from 3 to 5 ft. The contract cost for placing an estimated 1,200 tons of stone was \$14,400.

1971- 1972	Minor harbor-side slope repairs were made near the landward end of the breakwater. The new riprap was placed for a total cost of \$1400. The overall condition of the breakwater was good, except for some seaside slope stone slippage.

<u>Date(s)</u>	<u>Construction and Rehabilitation History</u>
1974	The landward 485 ft and seaward end of the breakwater were repaired using 3- to 5-ton armor stone and resetting existing stone. Landward repairs were mostly along the seaward side. Repair areas were mostly small, isolated areas of displaced stone which were rebuilt to the grade lines of surrounding sections. The total repair cost was \$28,850.
1977- 1978	Visual inspections indicate the breakwater was in good condition.
1984- 1986	Yearly visual inspections of the breakwater indicated it to be in good condition.

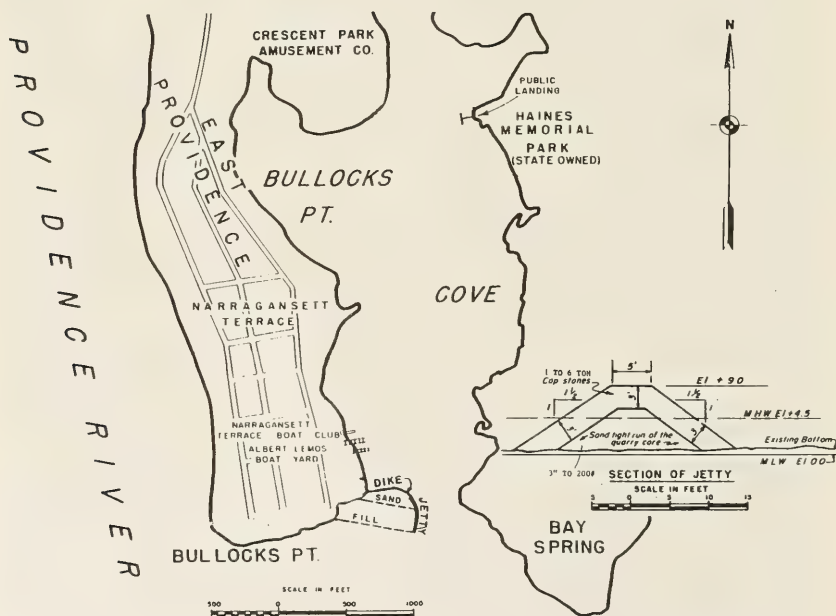
Figure 38. Plan view and design section of jetty at
 Bullocks Point Cove, R.I.

Date(s)	Construction and Rehabilitation History
1958	A 1,000-ft-long combination dike and jetty was constructed on the west side of the entrance to Bullocks Point Cove (Figure 38). The rubble-mound structure was constructed to an elevation of +9 ft mlw. The approximately 300-ft-long jetty had a 5-ft crown width, 1V:1.5H side slopes, a sand-tight core of 3-in. to 200-lb stone, and a cover layer of 1- to 6-ton stone. The contract cost for placing an estimated 10,000 tons of stone in the dike and jetty was \$54,000.
1965- 1977	Visual inspections indicated the dike and jetty were in excellent condition.
1980	An annual visual inspection indicated that the jetty and dike were in good condition.
1986	The present condition of the structure is not known.

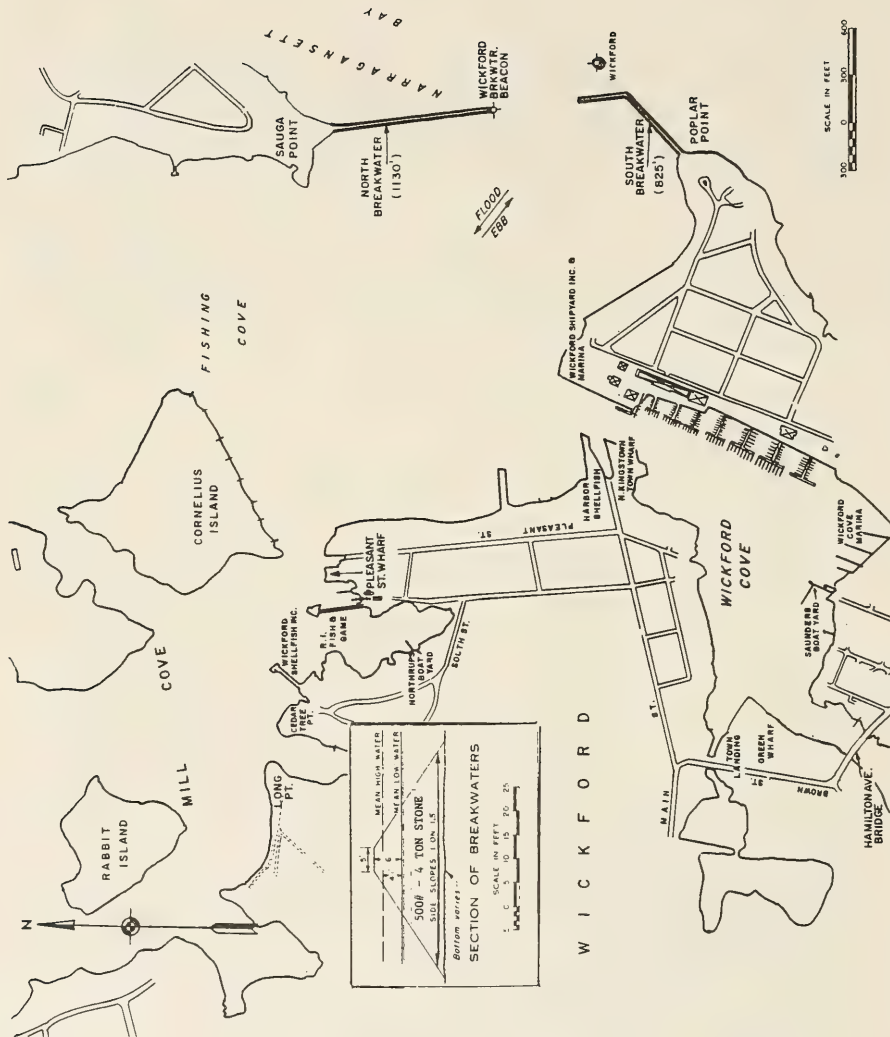
Figure 39. Plan view and typical section of breakwaters at Wickford Harbor, R.I.

<u>Date(s)</u>	<u>Construction and Rehabilitation History</u>
1949	The north and south breakwaters were constructed of rubble stone to lengths of 1,130 and 825 ft, respectively (Figure 39). Stone weighing from 0.25- to 4-tons was placed to a crown elevation of +6 ft mlw, a 5-ft crown width, and 1V:1.5H side slopes. Water depths varied from -2 to -10 ft mlw along the breakwaters' center lines. A total of 23,920 tons of stone was placed for a cost of \$117,250.
1962- 1977	Visual inspections show that both breakwaters have minor displacement of stone. As of 1977, the north and south breakwaters were in good and fair conditions, respectively.
1985	Yearly visual inspection of the breakwaters indicated they were in good condition.

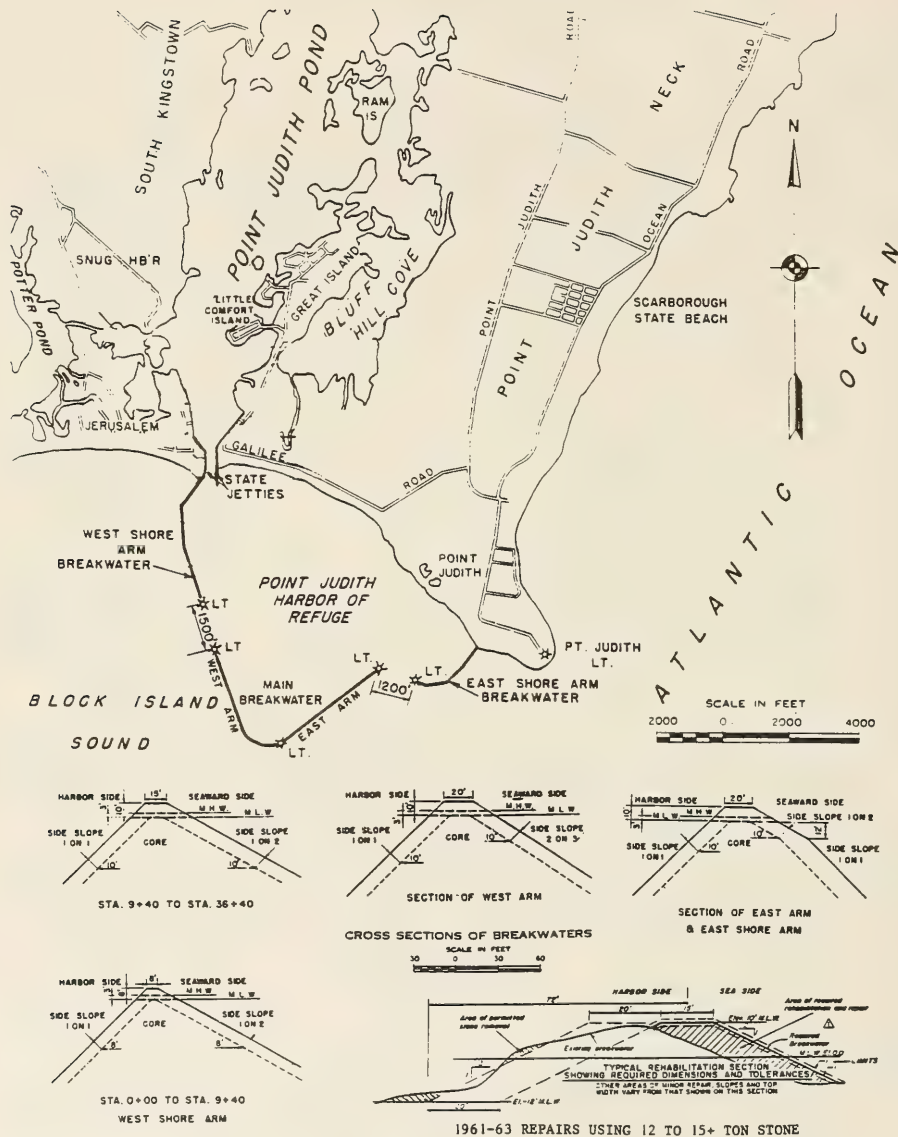
Figure 40. Plan view and typical sections of breakwaters at Point Judith Harbor of Refuge, R.I.

1927-1929	Repairs were made to the main and east shore arm breakwaters which had numerous deficiencies in cross section due to wave attack. The west shore arm breakwater was in good condition. Approximately 40,000 tons of stone were used for a total cost of \$203,400.
1935	The main breakwater was repaired using 6,760 tons of stone for a total cost of \$23,000.
1939-1941	Damaged sections of the main and east shore arm breakwaters, sustained during a 1938 hurricane, were repaired using new and reset stone. A total of 46,700 tons of new stone and 4,980 tons of salvaged stone were placed for a total cost of \$253,400.

1961- 1963	<p>The breakwaters were rehabilitated (Figure 40, inset) using 119,000 tons of stone for a total cost of \$1,771,900. The east shore arm was repaired from 9+50 to the reconstructed seaward end at 20+00. The main breakwater was repaired from the seaward end of the west arm at 0+00 to 4+00, at 10+50, and from 31+00 to the seaward end of the east arm at 69+25. Eleven areas, the largest covering 60 lin ft, of the west shore arm were repaired between 12+80 and the seaward end at 36+10. Stone placed on the structures weighed 12 to 15 tons, except for several sections along the east arm where a 15-ton minimum was specified. The repair areas required a +10 ft mlw crown elevation. The east and east shore arm repairs required a 15-ft crown width and 1V:2H side slopes. The west and west shore arm repairs specified 20- and 15-ft crown widths, respectively, with slopes of 1V:1.5H and 1V:1H on their sea and harbor sides, respectively. Prior to rehabilitation, crown elevations within the repair areas were typically from +4 to +9 ft mlw on the east and west arms, 0 to +8 ft mlw on the east shore arm, and +7 to +10 on the west shore arm. Crown elevations outside the repair areas were typically within 2 ft of the +8 and +10 ft mlw design elevations. Overall, the east arm and outer half of the east shore arm were the most deteriorated sections of the breakwaters prior to rehabilitation.</p>

1964- 1978	<p>Visual inspections show a gradual deterioration of the main and east shore arm breakwaters. The west shore arm had some displaced stone but was otherwise considered to be in good condition. By 1978, the</p>

Date(s)	Construction and Rehabilitation History
1964- 1978 (cont.)	main and east shore arm breakwaters were in poor to very poor condition with numerous deficiencies in cross section, and there were significant amounts of displaced stone on the harbor side of the structures at several locations.
1983- 1984	The east shore arm breakwater was repaired, and the main breakwater repairs were started but were not completed due to contractual difficulties. The east shore arm repairs were made using 12- to 15-ton stone and resetting existing stone. The majority of the repairs were located on the seaward half of the breakwater from 10+50 to 20+30. The breakwater was rebuilt to a +10 ft mlw crown elevation, a 20-ft crown width, and slopes of 1V:2H and 1V:1H on the sea side and harbor side, respectively. The cost of repairs was \$702,500 for 20,275 tons of new stone and \$81,870 for resetting existing stone. The incomplete main breakwater repairs were identical to the east shore arm repairs in stone weight and cross section geometry, except for the side slopes which were 1V:1.5H from 0+00 to 20+34 and 1V:2H from 20+34 to 67+25. The contract, awarded in the amount of \$2,275,000, called for placing 57,600 tons of stone and resetting existing stone.

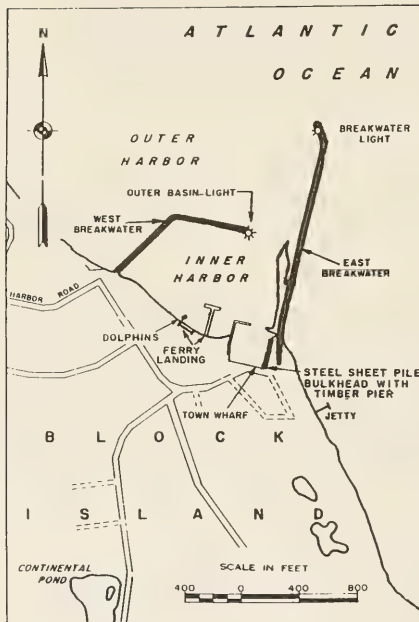
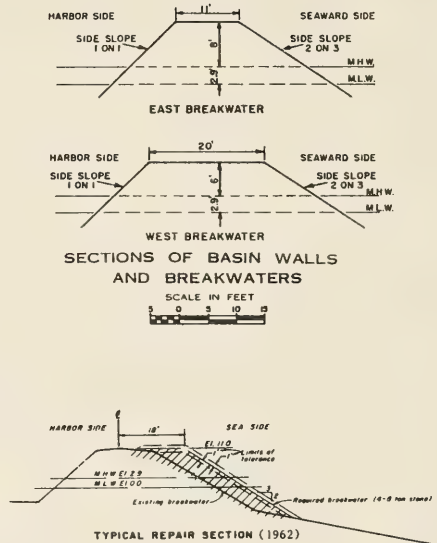
Figure 41. Plan view and typical sections of breakwaters at Block Island Harbor of Refuge, R.I.

Date(s)	Construction and Rehabilitation History
1870- 1894	The east and west rubble-mound breakwaters were constructed to lengths of 1,950 and 1,100 ft, respectively (Figure 41, plan view). The east breakwater was built to +10.9 ft mlw with an 11-ft top width, and the west breakwater was built to +8.9 ft mlw with a 20-ft crest width. The sea and harbor side slopes on both structures were 1V:1.5H and 1V:1H, respectively. A total of 107,400 tons of stone was used in constructing the east breakwater, and at least 18,400 tons of stone were used on the west breakwater. In 1890 minor repairs were made to the east breakwater using 420 tons of stone.
1903- 1906	The east breakwater was repaired using a total of 19,970 tons of stone at a total cost of \$42,900.
1914- 1916	Repairs were made at the landward and seaward ends of the east breakwater using a total of 5,930 tons of stone.
1939	Repairs were made to the east breakwater using 3,360 tons of stone for a total cost of \$21,000.

1950	The west breakwater was repaired to its design cross section using 0.25- to 6-ton cover stone and "run of quarry" core stone. Typical crest elevations prior to repairs were from 1.5 to 3.0 ft below the design elevation of +8.9 ft mlw. Total cost of the repair was \$127,100 using 12,900 tons of stone.
1955	An 800-ft section of east breakwater was repaired and sand tightened by placing 0.75-in. to 200-lb core stone and 1- to 6-ton cover stone. The stone was placed on the breakwater's seaward side slope beginning at a point opposite the northeast corner of the inner basin and terminating about 750 ft from the structure's seaward end. The cross section had a crown elevation of +11 ft mlw, the crown width extended seaward 25 ft from the existing breakwater center line, and the side slope was 1V:1.5H. A total of 12,000 tons of stone was placed for a total cost of \$125,000.
1962- 1963	The seaward 842 ft of the east breakwater were repaired using 4- to 8-ton stone. Prior to repair, center-line elevations were from +9 to -2 ft mlw on the seawardmost 200 ft, +9 to +12 ft mlw along the remaining 642 ft of repairs, and +10 to +12 ft mlw landward of the repairs. The repair crown section consisted of a +11 ft mlw crown elevation, an 18-ft crown width, and slopes of 1V:1H and 1V:1.5H on the harbor and sea sides, respectively. Most of the stone was placed on the sea-side slope. A total of 11,700 tons of stone was used for a total cost of \$138,000.

Date(s)	Construction and Rehabilitation History
1977	Inspections up to this time indicated the west breakwater was in good condition and the east breakwater was in fair to good condition. Repair work was needed on the seaward 150 ft of the east breakwater where settlement and loss of sea-side slope stone had occurred since the 1962-63 repairs. Maintenance was subsequently performed.
1984-1987	Yearly visual inspections indicated the breakwaters were considered to be in good condition.

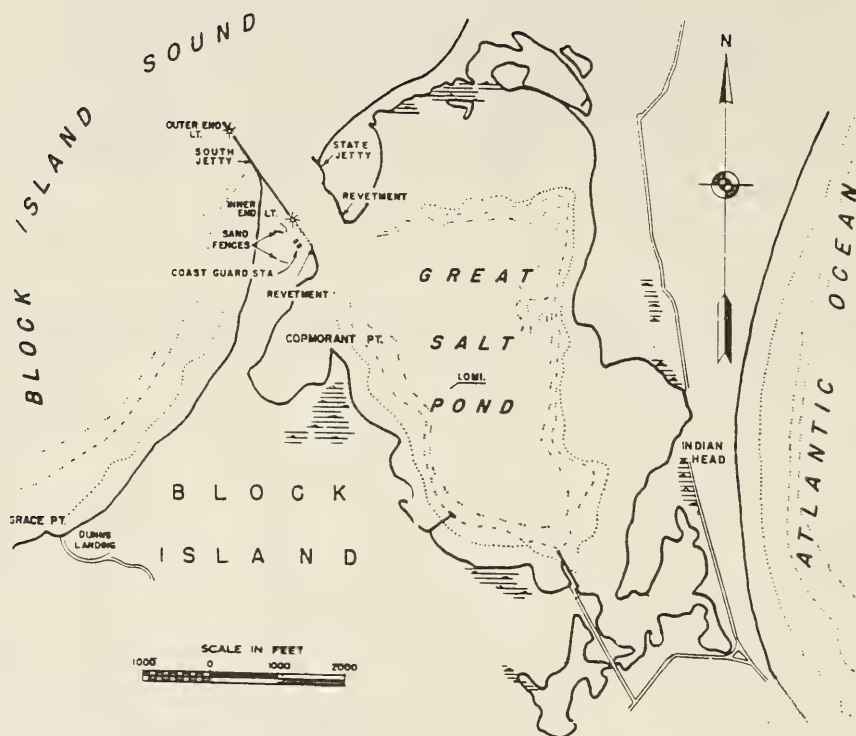
Figure 42. Plan view and cross section of south jetty at Great Salt Pond, Block Island, R.I.

<u>Date(s)</u>	<u>Construction and Rehabilitation History</u>
1896- 1905	A 1,690-ft-long rubble-mound jetty was constructed on the south side of the inlet to Great Salt Pond (Figure 42). The design cross section consisted of a +8 ft mlw crown elevation, a 15-ft crown width, and slopes of 1V:2H and 1V:1H on the sea and channel sides, respectively. The structure's seaward end extended approximately 400 ft beyond the -18 ft mlw contour. A total of 66,860 tons of stone were placed at a cost of \$84,900.
1935	Minor repairs were made to the jetty using 1,600 tons of stone for a cost of \$5,700.
1965- 1977	Visual inspections indicated the jetty was in poor to fair condition and in need of repairs. The outer half of the jetty had many void spaces and areas of displaced stone. Subsequent repair work was performed.
1982	Annual visual inspection indicated the jetty to be in good condition.
1986	The present condition of the jetty is not known.

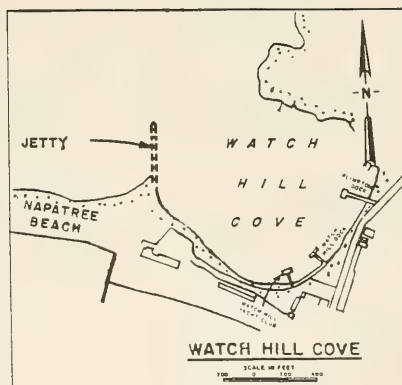
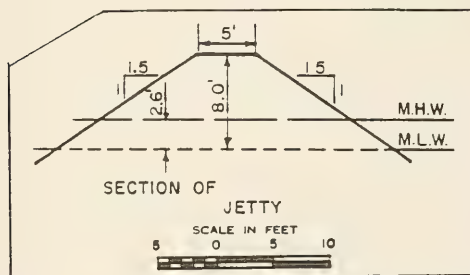
Figure 43. Jetty at Watch Hill Cove, R.I.

- 1948 A 400-ft-long rubble-mound jetty was constructed on the west side of Watch Hill Cove (Figure 43). The jetty was built to an elevation of +8.0 ft mlw, a top width of 5 ft, and 1V:1.5H side slopes. The core consisted of run of quarry stone and cover stone weighed between 600 lb and 2 tons. The cost for placing 456 tons of stone was \$3,990.
- 1974 The jetty was in good condition, with only minor displacement of stone noted along its outer 150 ft.
- 1982-1986 Annual visual inspections indicated the jetty was in good condition.

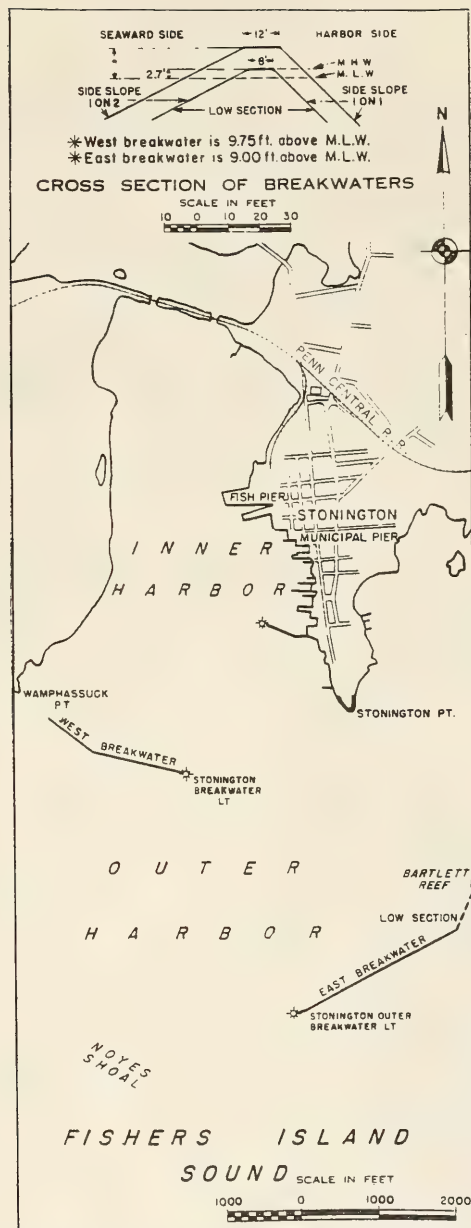
Figure 44. Plan view and cross sections of breakwaters at Stonington Harbor, Conn.

<u>Date(s)</u>	<u>Construction and Rehabilitation History</u>
1875- 1894	The west and east breakwaters, 2,025 and 2,900 ft long, respectively, were constructed using total stone quantities of 94,200, and 118,500 tons, respectively (Figure 44). The structures crown widths were 12 ft, and side slopes were 1V:2H and 1V:1H on the sea and harbor sides, respectively. The east and west breakwater crown elevations were +9 and +9.75 ft mlw, respectively. The easternmost 500 ft of the east breakwater was built lower than the remaining breakwater, having a crown elevation of +2.7 ft mlw and an 8-ft crown width. Total construction costs were approximately \$210,000.
1958	The breakwaters were repaired using 0.5- to 4-ton stone. Approximately 4000 tons of stone were placed to bring low sections up to their original design geometries (Figure 44, insert). The total repair cost was \$38,000.
1962- 1977	Visual inspections indicated the breakwaters were in good condition.

1984	Yearly visual inspections indicated that the breakwater was in good condition.

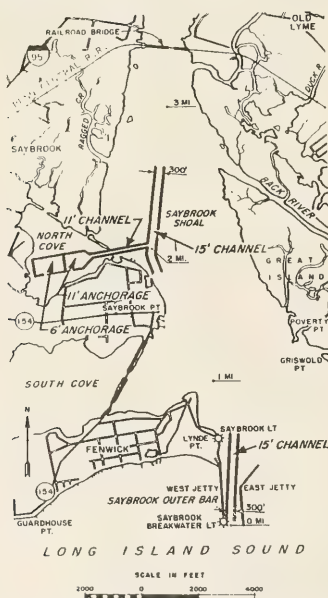
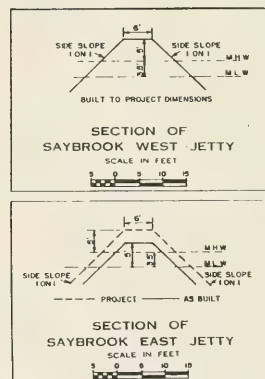
Figure 45. Plan view and design sections of jetties at the mouth of the Connecticut River, Saybrook, Conn.

Date(s)	Construction and Rehabilitation History
1873- 1885	The east and west jetties were constructed at the mouth of the Connecticut River to lengths of 2,300 and 2,250 ft, respectively (Figure 45). The jetties had +5 ft mlw crown elevations, 6-ft crown widths, and 1V:1H side slopes.
1904 1905	The jetties were repaired using 7,650 tons of stone for a total cost of \$9,400. The jetties were restored to crown elevations of +5 to +6 ft mlw and crown widths of 6 ft.
1914- 1916	The west jetty was repaired and raised to a crown elevation of +8.5 ft mlw. Approximately 16,000 tons of stone were used and 85 cu yd of concrete were placed at the landward end for a total cost of \$26,000.
1966- 1978	The jetties were considered to be in good condition during visual inspections.
1984	Annual visual inspection of the jetties indicated they were in good condition. The jetties do not appear to have a repair history subsequent to 1916.
